# Manhole Inspection Summary

Manhole # S45MM\_028MH

Insp Date: **3/25/08 1:27 PM**

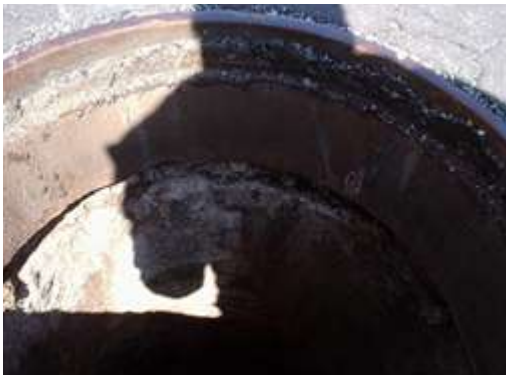
Defect 2

☒ **Leaks**

Frame Leaks

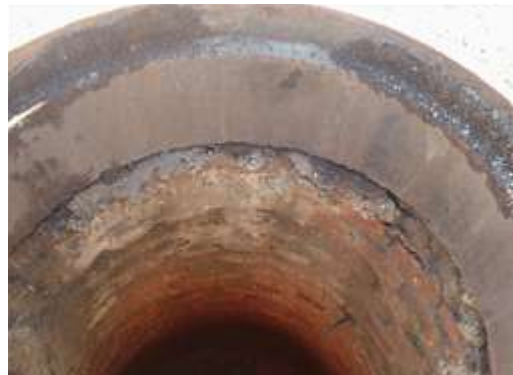
Defect 1

Condition: ☐ Sound ☐ Cracked ☐ Root Intrusion ☒ **Loose Brick** ☐ Deteriorated

Infiltration: ☐ None ☐ Joint ☐ Cracks ☒ **Mortar** ☐ Roots ☒ **Wall**

Loose Bricks

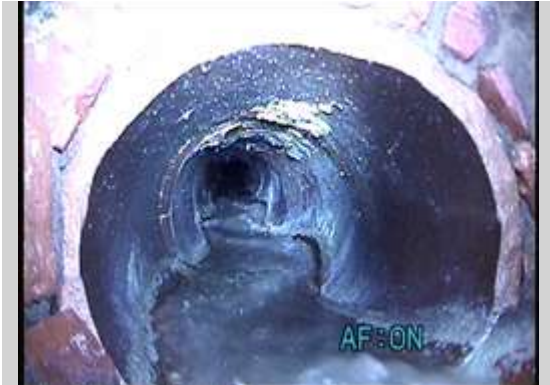
12 O'Clock Outflow

8 in. Circular Gravity Sewer  
Pipe Out @ 12 O'Clock

Pipe Height: **8.4** (in.) Rod and Bar (Angled)  
Pipe Material: **Clay** ☐ Pipe Lined  
Invert Depth: **9.80** (ft.) Flow Characteristics: **Fast**  
Deposits: ☐ None ☐ Mud ☐ Sludge ☐ Debris ☒ Grease  
Silt Depth: **0.5** (in.) Deposits Extent: **Light**  
Infiltration: **None** Pipe Seal Cond: **Sound**

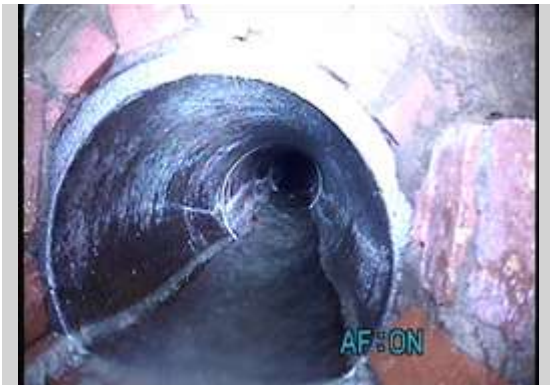
9 O'Clock Inflow

8 in. Circular Gravity Sewer  
Pipe In @ 9 O'Clock

Pipe Height: **8.4** (in.) Rod and Bar (Angled)  
Pipe Material: **Clay** ☐ Pipe Lined  
Invert Depth: **9.70** (ft.) Flow Characteristics: **Fast**  
Deposits: ☒ None ☐ Mud ☐ Sludge ☐ Debris ☐ Grease  
Silt Depth: (in.) Deposits Extent:  
Infiltration: **None** Pipe Seal Cond: **Sound**
